Manhole Inspection Summary

Manhole # S17I__011MH

Insp Date: **10/9/07 9:22 AM**

Location Address: **2330 BALTIMORE ST**

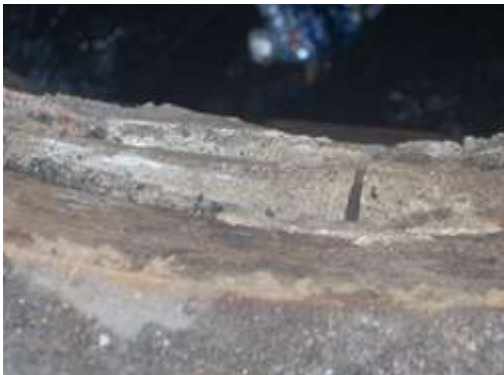
Defect 3

Offset: **1** (in.)

FRAME OFFSET

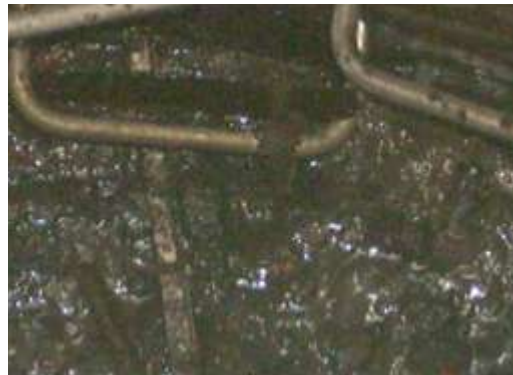
Defect 2

☒ **Evidence Of Surcharge** Depth: **2** (ft.) ☐ Active Surcharge Present

SURCHARGE EVIDENCE ON STEPS

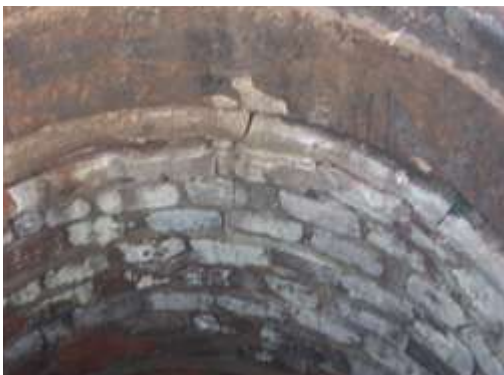
Defect 1

Condition: ☐ Sound ☒ **Cracked** ☐ Root Intrusion ☐ Loose Brick ☐ Deteriorated

CRACKED CHIMNEY

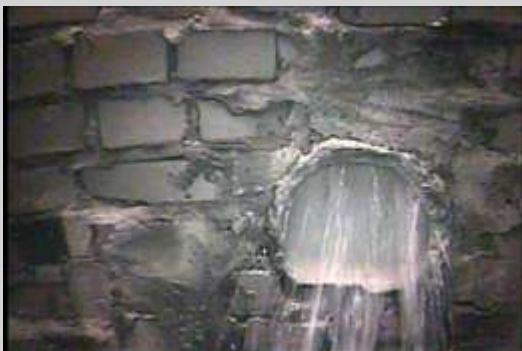
3 O'Clock Inflow

CRACKED CHIMNEY

Pipe Height: **7.2** (in.) Rod and Bar (Angled)
Pipe Material: **Clay** ☐ Pipe Lined
Invert Depth: **8.77** (ft.) Flow Characteristics: **Slow**
Deposits: ☐ None ☐ Mud ☐ Sludge ☒ **Debris** ☐ Grease
Silt Depth: **7** (in.) Deposits Extent: **Heavy**
Infiltration: **None** Pipe Seal Cond: **Sound**

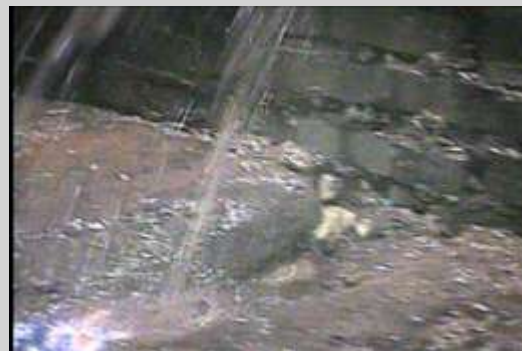
Drop In @ 3 O'Clock

CRACKED CHIMNEY

Drop: **Outside** Rod and Bar
Angled: **Yes** Reading: **9.81** (ft.)
Inv Depth: **10.81** (ft.)
Drop Condition: **Clogged**
